SEISMIC VULNERABILITY OF THE HUANCARO-SANTIAGO ECOSYSTEM - CUSCO

ABSTRACT: The research, the objective is to analyze the geological and geotechnical characteristics of the foundation terrain, as well as the probability of earthquakes and the fragility of the buildings, to finally determine the degree of vulnerability, In the Huancaro micro-basin, as part of the urban expansion of the city of Cusco, base maps were drawn up to identify seismic vulnerability, concluding that there is a high probability of earthquakes occurring between 6 and 7 degrees on the Richter scale and because of the nature of the soils, which are of lacustrine origin (70%) and alluvial fluvial (30%); The fragility of the constructions must also be considered, which especially in the peripheral zones are precarious constructions of adobe without any planning (70%).

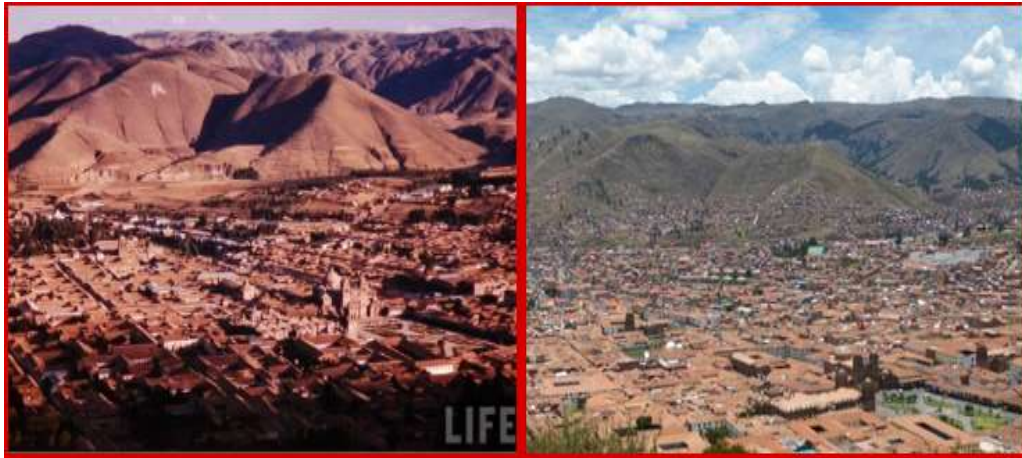
Figure 3. The city of Cusco (1960) (a), and the (b) current town of Cusco and the city of Cusco (2019), Source: Life

Figure 3 shows the population explosion in recent years has increased alarmingly, in the study area, did not have a flat land surface, was rugged terrain, had diverse geomorphology, had elevations, slopes, orientations, stratifications, rock formation, soil types, etc., which is why the research took an additional time as in figure 2.

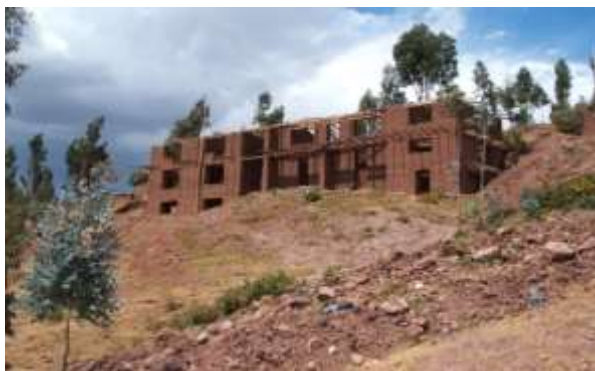
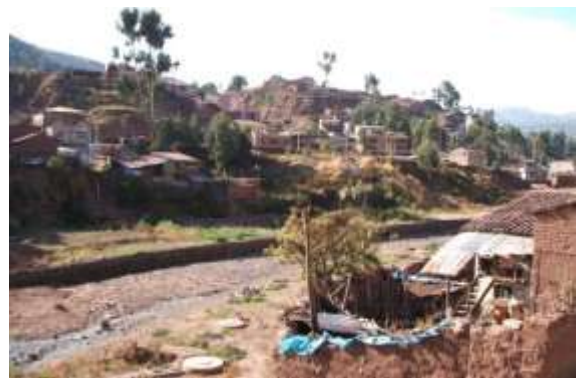
Figure 4: Self-build adobe homes up to three stories (a) and the (b) houses in the nearby part of the Huancaro river, Own source

Figure 4 shows buildings of up to three floors in a highly seismic zone that constitute very vulnerable housing and on the right side the Huancaro River, where there are houses in the riverbed in which its flow increases by 50 times in the rainy season.
