# TROPHIC STATUS INDEX OF THE WATERS OF THE PANTANOS DE VILLA PROTECTED NATURAL RESERVE, CHORRILLOS, PERÚ

**ABSTRACT:** The objective of the investigation was to determine the trophic state index of the waters of the protected nature reserve "Pantanos de Villa", located in Chorrillos Lima Perú. Likewise, were evaluated the most important physicochemical characteristic parameters of the waters of the main lagoon of the area called "Genesis". For the study, it obtained 24 liters of water of the Genesis lagoon from three strategic points taken at the convenience, finding that it had an electrical conductivity at point 1 of 4315 uS/cm, for point 2 a value of 4340 uS/cm. At point 3, a value of 4320 uS/cm, all values exceeded what is established by the Environmental Quality Standard (ECA), which is 1000 uS/cm for the water of category 4 (Conservation of the aquatic ecosystem) subcategory E1 (Lakes and lagoons). As for another parameter, such as dissolved oxygen, in point 3, it resulted in the value of 6.55 mg/L, lower than ECA for water (12.22 mg/L). The total phosphorus concentration, nitrates, suspended solids, and chlorophyll concentration were also analyzed to determine the trophic

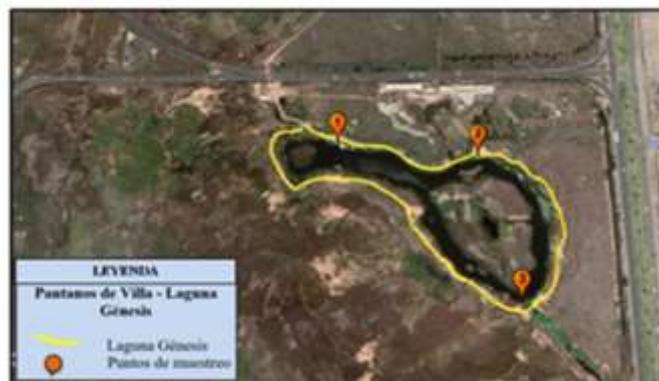
The study area of Los Pantanos de Villa is a protected natural area that is located on the coast of the Chorrillos district in the province of Lima, department of Lima, in Peru, with an area of 2.63 km<sup>2</sup> and has a degree Protection of Wildlife Refuge as shown in figure 1.

Figure 1: Study area. Source: Google maps

The parameters of pH, temperature, dissolved oxygen, and electrical conductivity were measured on-site [7]. The nomenclature used was S1 and P1 to indicate sampling point 1 at the surface and the depth or bottom, and so on for points 2 and 3, as shown in Figure 1. The samples were preserved at 6 °C and in darkness following the recommendations of the Water Quality Monitoring Protocol. The Secchi disk was used to measure the transparency of Genesis Lagoon at each sampling point.

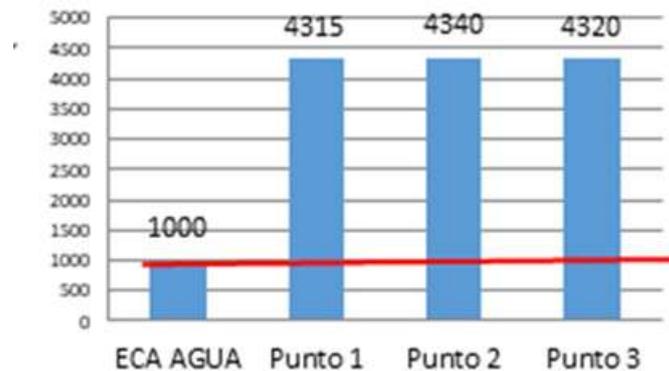
Figure 2: Shows sample points and electric conductivity and water ECA values (red line ECA level).

The electrical conductivity as shown in figure 2 and table 2, the values at the 3 sampling points exceed the maximum value established in the ECA WATER (DS N ° 004 -2017 MINAM), which is 1000 uS/cm for lakes and ponds

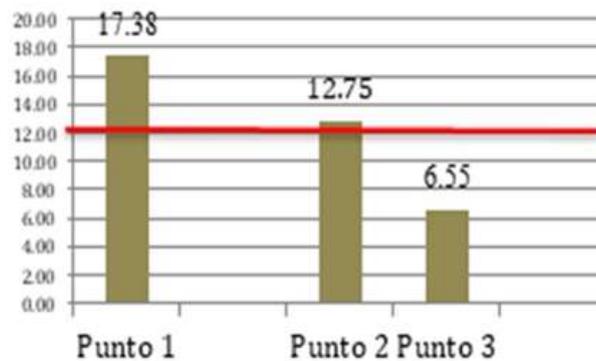
Figure 3: Dissolved oxygen, and sample points with water ECA values (red line ECA level).

The dissolved oxygen (DO) at the 3 sampling points are indicated in Figure 3, compared to the minimum value established in the ECA WATER of 12.22 mg / L, it can be seen that in the sampling point 3 where it was evidenced presence of aquatic macrophytes, the value is 6.55 mg / L, which is well below the value established in the ECA water.
